RCD330 plus. Rear Cam coding, Amp line out and control.

Noname version with carplay 6RD035187B.

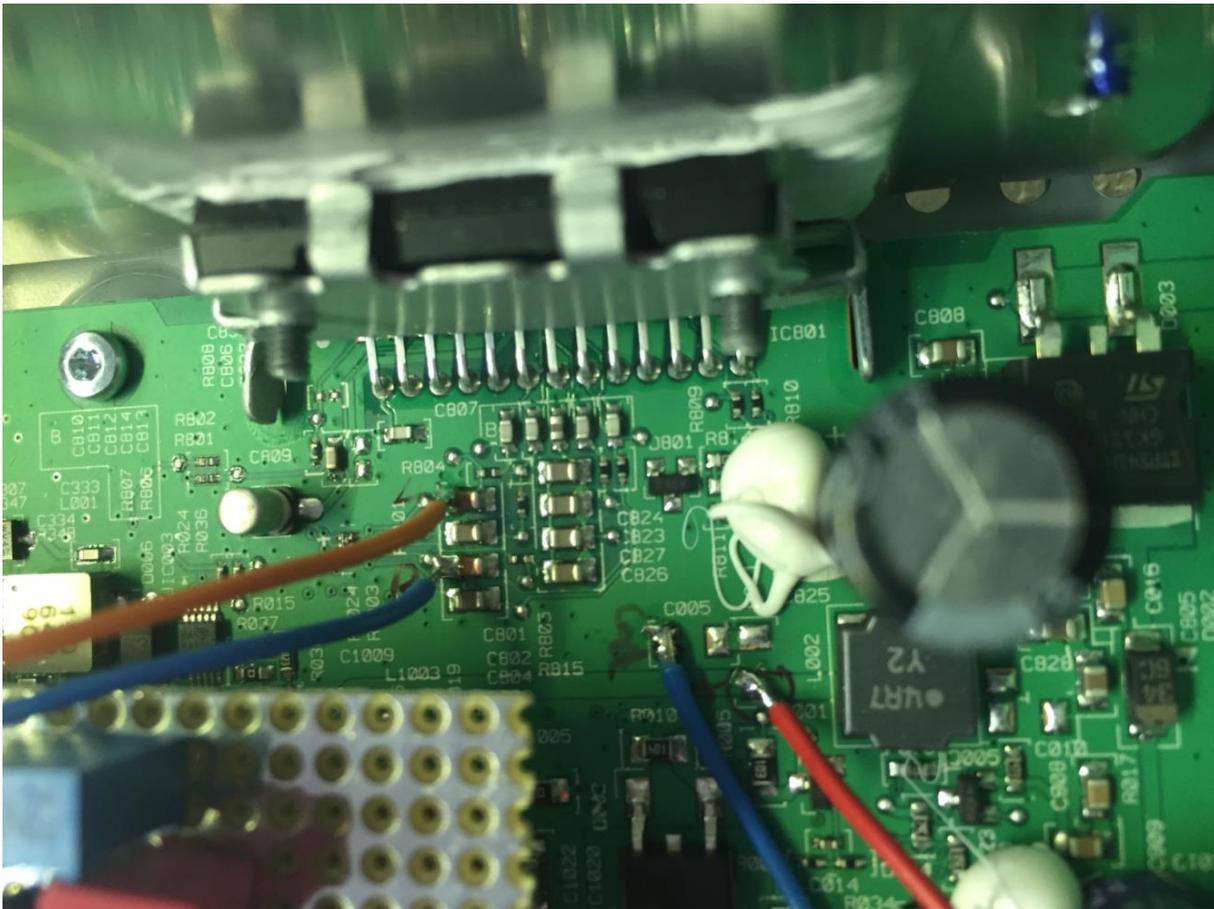
Front line out signals can be found as shown in the picture marked L and R:

The circuit board is a small op-amp to boost the line signal, this is probably not needed as the signal is pretty strong.

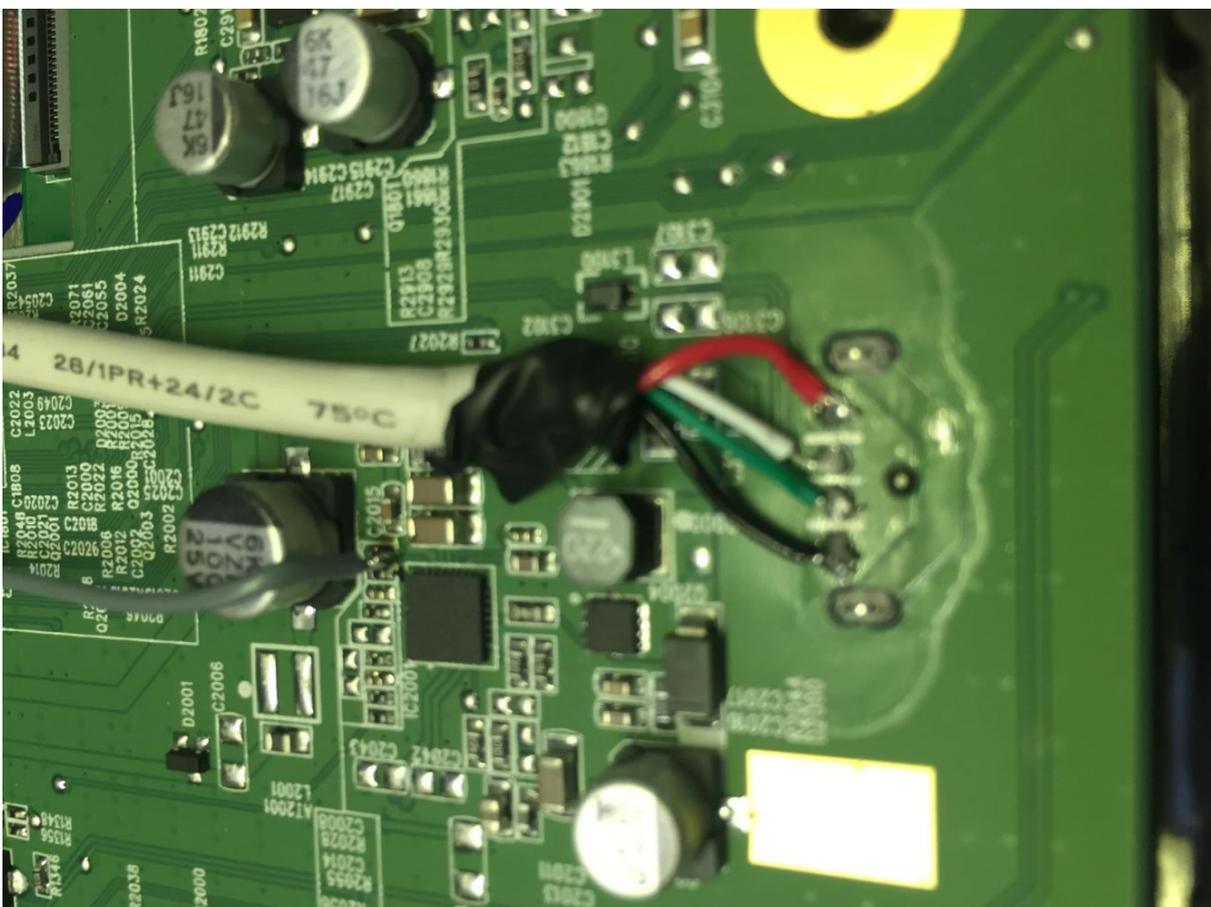
If you want the USB routed to the rear you can solder a standard cable here:

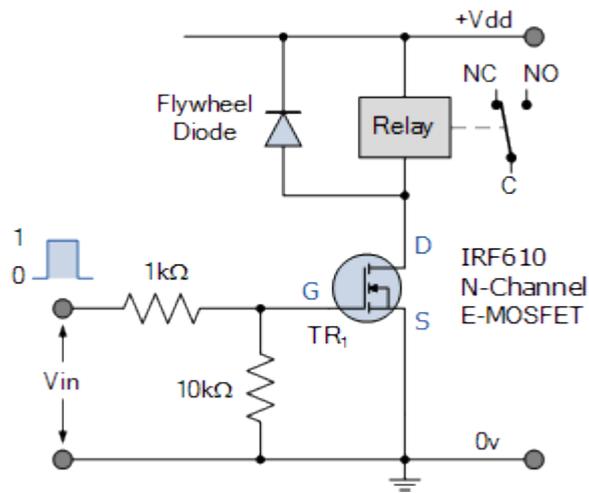
The grey wire is the amp remote signal. It is a control signal to the backlight and it is perfect for the purpose as it shuts down immediately after the power button is pressed, thus turning off the amp before dc thumps occurs.

The signal is very weak and you can't draw any current or the backlight fades, so the solution is a mosfet driven relay like this:
